MassDEP Geographic Response Plan – 2016 Menemsha Pond (CI-24)

October 26, 2016

Exercise Name	2016 Menemsha Pond (CI-24) GRP Exercise
Exercise Dates	October 26, 2016
Scope	This exercise is a Full Scale Exercise, planned for approximately six hours in Aquinnah and Chilmark, MA and upon the waters of Menemsha Creek. Exercise play is limited to Menemsha Creek and Menemsha Basin, and the adjacent shoreline.
Mission Area(s)	Response
Core Capabilities	Environmental Response/Health and Safety, Operational Coordination, Operational Communications
Objectives	<p>Objective 1: Demonstrate the ability to deploy oil spill equipment from one or more MassDEP pre-positioned oil spill response trailers utilizing common Geographic Response Plan (GRP) tactics.</p> <p>Objective 2: Demonstrate the ability to assemble a spill response organization utilizing Incident Command System (ICS) principles through development and execution of an Assignment List (ICS 201) and implementation of on-site incident management and tactical operations.</p> <p>Objective 3: Demonstrate the ability to effectively communicate between multiple local, state, and federal agencies including fire departments, police departments,

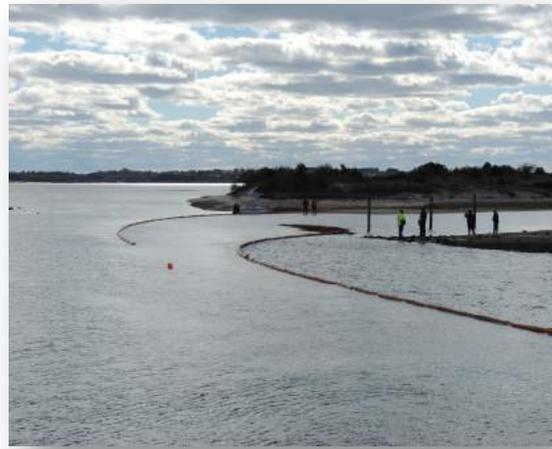
Diversion boom tactic moving oil surrogate (peat moss) toward the south shore of the entrance to West Basin.

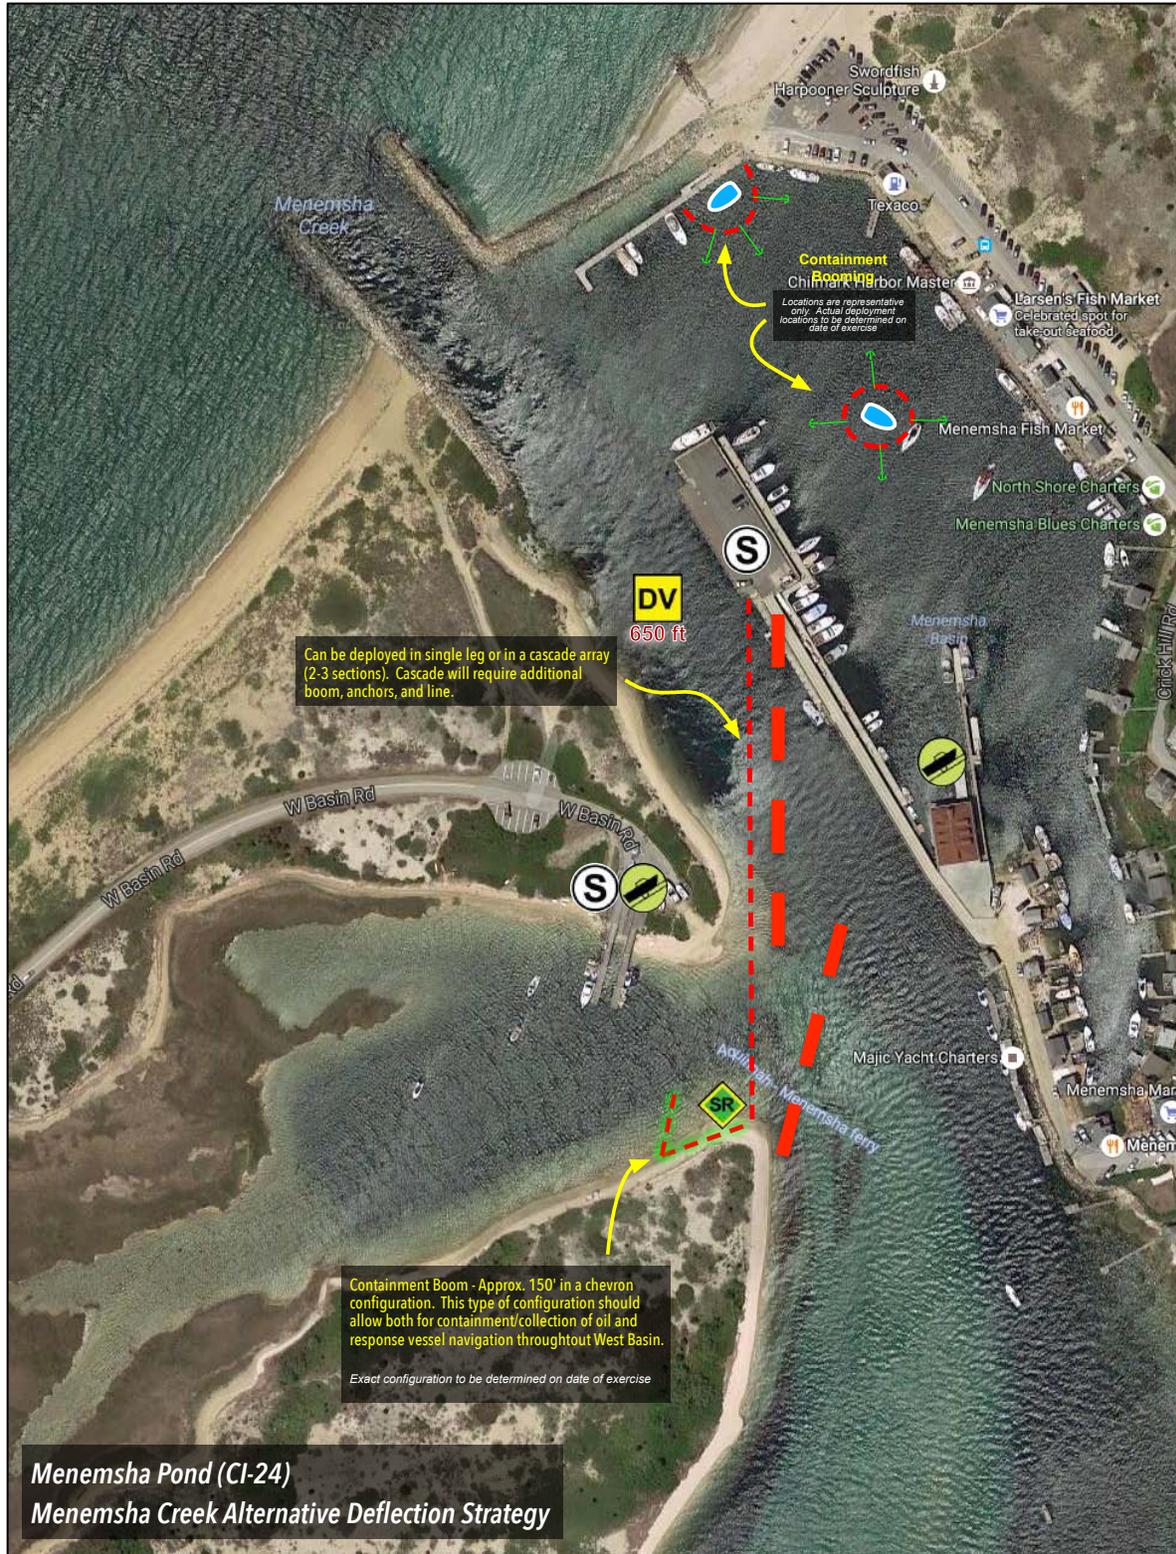
Figure 1. The Initial GRP Tactic was modified to a cascade array with 400 foot and 300-foot sections as depicted with the larger dashed lines.

Analysis: Tactic was deployed as planned and modified during an operational brief held immediately following the classroom training. This tactic proved effective in the lighter currents 1-2 hours after low tide. Surrogate was diverted along the boom face, directed toward the western shore of the channel, and then captured by the diversion boom on the south side of the entrance to the West Basin.

Area for Improvement 1: Modify CI-26 to include the cascading diversion strategy used in this exercise. Permanent anchor points for both tactics will require some further consideration.

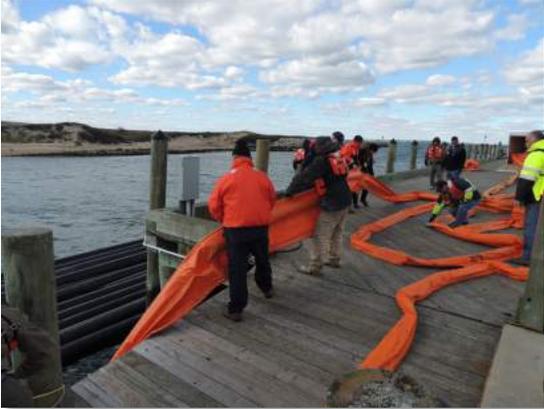
Shore team deploying boom off the pier and over dredge pipes.

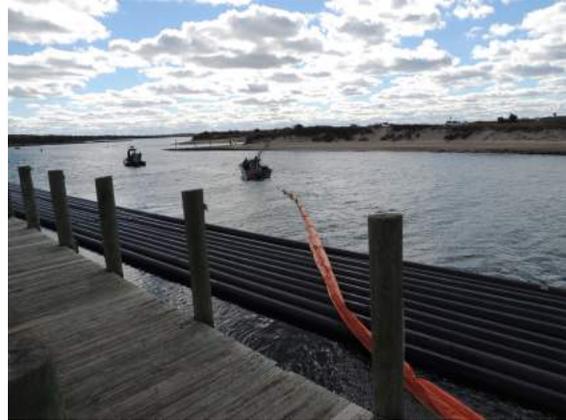
Boom being pulled over dredge pipes and toward the south shore of the entrance to West Basin.

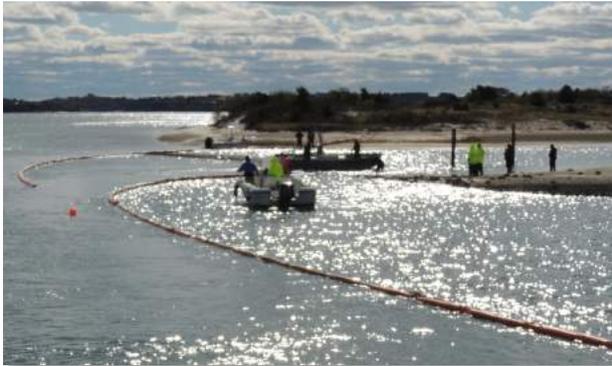
Analysis: The forces placed against the boom tied to the piling eventually broke the pile that the southern end of the deflection boom was attached to (the piling had been in the eater for some time and showed outward signs of age and deterioration). There is still some concern that at maximum flood, the strategy deployed would not remain in place and effectively collect oil entering Menemsha Pond. An additional exercise should be conducted at some point in the

Pile used as an anchor point for the north leg of the diversion tactic breaks. Chilmark Shellfish boat and shore team cut the pile from the boom and retrieve it.

Area for Improvement 2: Additional testing with smaller boom (6-inch) should be conducted and further consideration should be given to developing tactics inside Menemsha Pond in the event that this diversion/deflection strategy can hold up.

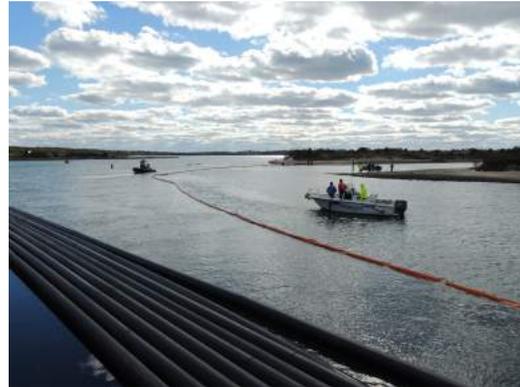
Boom is reconnected by Wampanoag Tribe vessel.
