# Massachusetts Department of Environmental Protection Three-Year Geographic Response Plan Testing Program

## After-Action Report on Marblehead Harbor (NS-27) GRP Test

Testing Date: June 30, 2010

Developed by Nuka Research and Planning Group, LLC  
July 2010

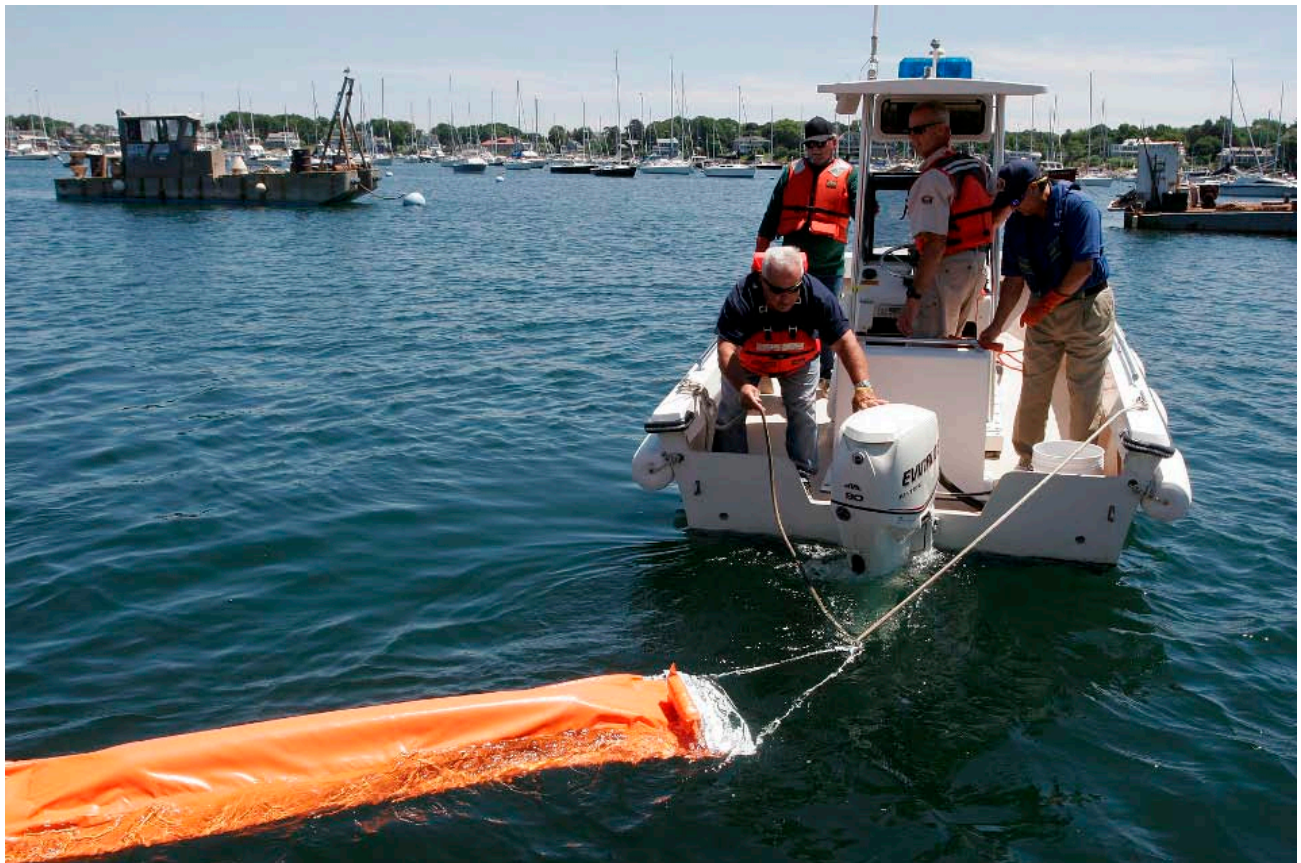
*Figure 4. Attaching the boom to tow to the deployment site*

The testing portion was run based on the principals of the Incident Command System (ICS), although the ICS portion of the exercise was not the prime objective. Lt. Cerrutti from Marblehead Fire Dept served as Incident Commander. After meeting at the Marblehead Harbormaster parking lot on Ferry Street for a review of the day's objectives by Elise DeCola, a safety briefing by Safety Officer Breen, and assignments for the incident by Incident Commander Cerrutti, the group unloaded boom from the Swampscott oil spill response trailer. They deployed three sections of boom, towed by two vessels, for one version of DV-01b, a diversion boom array (see Figure 4). There were many moorings in the harbor which made it difficult to maneuver while towing the boom. The smaller vessel (zodiac) was used solely to set anchors (see Figure 5). There was access from the street to set the shoreline anchor. An iron bolt in the rocks was ultimately used as a permanent anchor after some difficulty using the rebar.

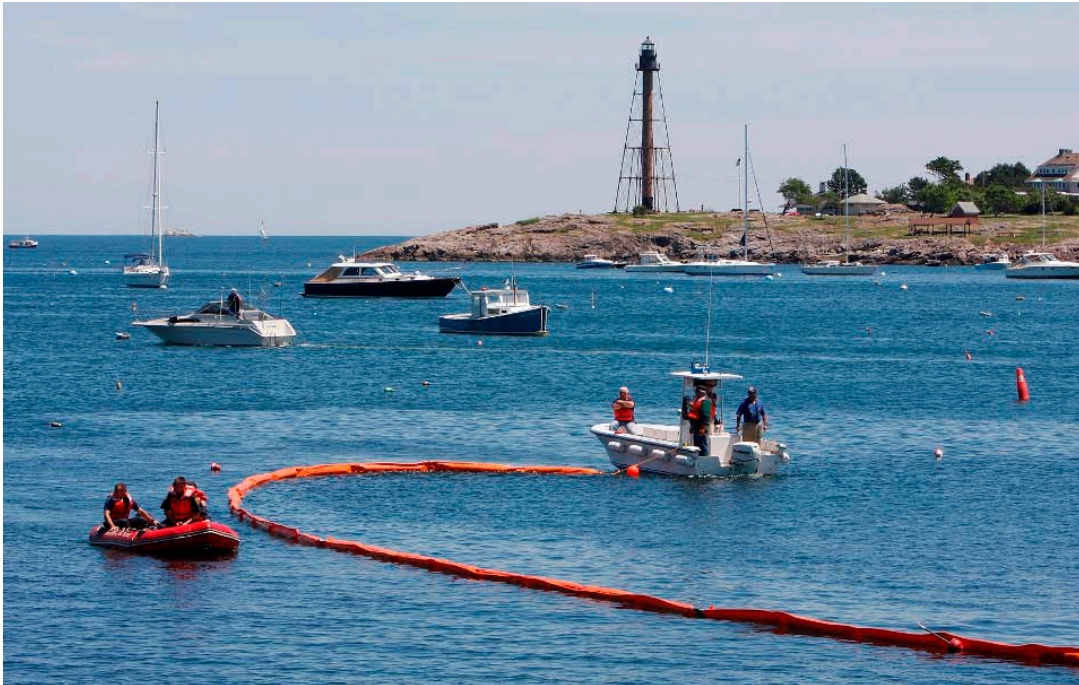
Figure 5. Vessels working with boom in Marblehead Harbor

The wind did pick up towards the end of the deployment, but it did not prove to be a major challenge. After the group returned, rinsed, and stowed the boom a culvert plug was brought out of the trailer and semi-inflated for informational purposes, since there had been a culvert at the shoreside recovery area. It was noted that a culvert plug should be added to the GRP tactics for this site, to ensure that, if the beach were used for recovery, oil would not enter the large culvert/outfall. The entire deployment was completed in about two hours.
