MassDEP Geographic Response Plan – 2018 Lynn Harbor (NS-29) Exercise

After Action Report

May 17, 2018

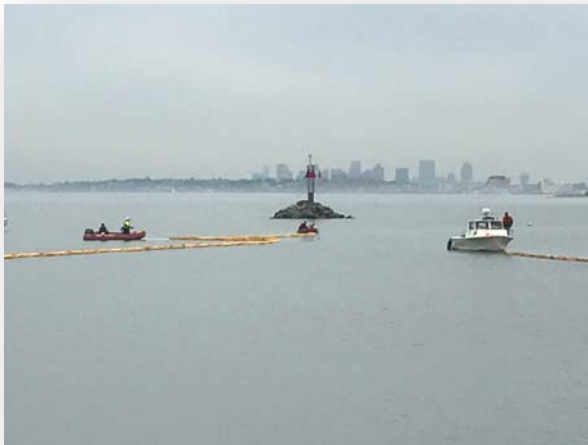
Vessels from Lynn and Nahant deploy oil spill boom in Lynn Harbor.

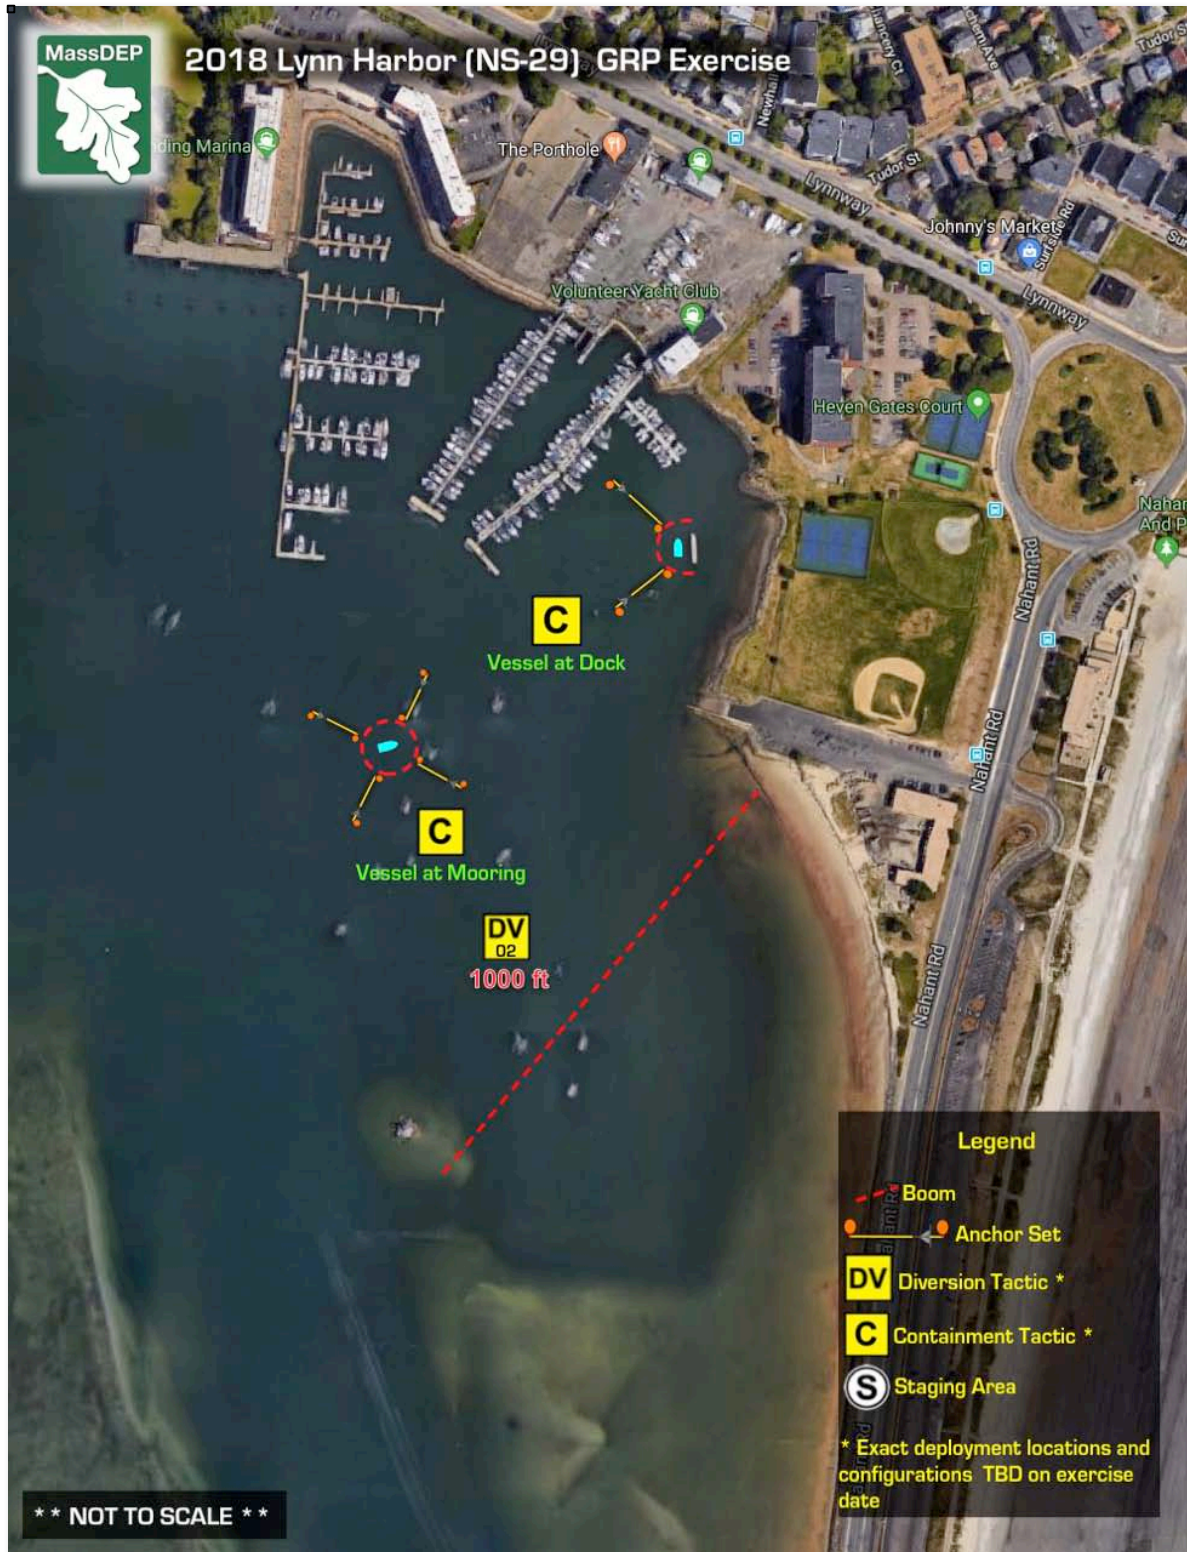
Figure 2. NS-29 DV-02 Tactic

Implement Tactics in GRP	Diversion Boom (DV-02)	<ul style="list-style-type: none"> • Performed Without Challenges (P) • Engine 3 expertly deployed surrogate but the tide was not very strong to sufficiently test the strategy. The wind was the primary driver and put the surrogate into the boom but it did not divert to shore. • DV-02 was a good training strategy but a review of the GRP is necessary to determine whether this strategy would be effective in diverting oil in Lynn Harbor to the designated shore side recovery location. It would seem that oil entering Lynn Harbor would likely follow the channel into the harbor because that is where the current would be strongest. Therefore, an additional section of boom deployed in a cascade array extending into the main channel should be considered. Such a length would have to be, at a minimum, 600 feet of 18" boom. The exercise also revealed that the designated shore side recovery location is most likely ideally placed. Recommendation: <u>Review and/or revise DV-02 in NS-29 to improve its effectiveness.</u> • Multiple anchors were used to deploy the 1000' tactic. The use of trip lines allowed for easy adjustment of the anchors for deploying the diversion booming tactic.

Analysis: DV-02 was a good training strategy but a review of the GRP is necessary to determine whether this strategy would be effective in diverting oil in Lynn Harbor to the designated shore side recovery location. It would seem that oil entering Lynn Harbor would likely follow the channel into the harbor because that is where the current would be strongest. Therefore, an additional section of boom deployed in a cascade array extending into the main channel should be considered. Such a length would have to be, at a minimum, 600 feet of 18” boom. The exercise also revealed that the designated shore side recovery location is most likely ideally placed.

Area for Improvement 6: Review and/or revise DV-02 in NS-29 to improve its effectiveness.

6. Revise DV-02	Review and/or revise DV-02 in NS-29 to improve its effectiveness.	Planning	Nuka Research	Mike Popovich	6/15/18	9/15/18
Core Capability 2: Operational Coordination	None.	None.	N/A	N/A	N/A	N/A	N/A
Core Capability 3: Operational Communications	None.	None.	N/A	N/A	N/A	N/A	N/A

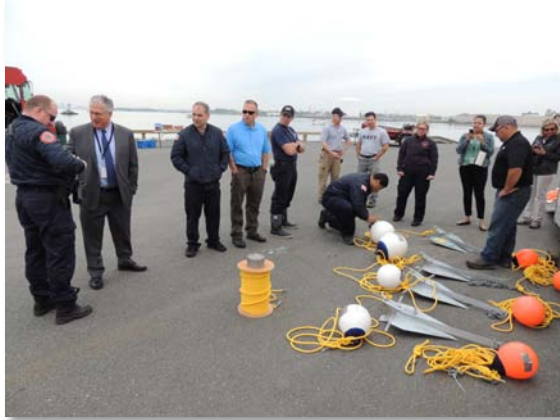
Strength 2: Hands on training in multiple stations were very effective. Many participants had never connected the boom together. The anchor station benefitted greatly from the diagram of how to put together an anchor system.

Hands on training is conducted on assembling anchors for the exercise.

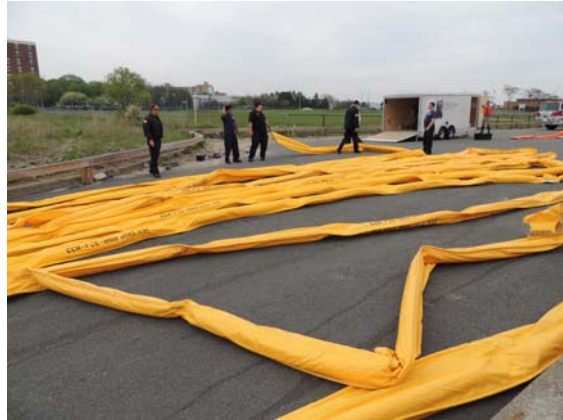
Analysis: In the Lynn trailer, there was a damaged section of 18” boom and one of the 12” sections of boom did not have any connection pins attached to one end of the boom.

Boom from the Lynn trailer is faked out on the DCR boat ramp prior to being deployed from the boat ramp.

Area for Improvement 1: Repair or replace sections of boom requiring repair in the Lynn Trailer.

Core Capability	Issue/Area for Improvement	Corrective Action	Capability Element ¹	Primary Responsible Organization	Organization POC	Start Date	Completion Date
Core Capability 1: Environmental Response/Health and Safety	1. Repair boom in Lynn Trailer	Repair damaged sections of 12" and 18" boom.	Equipment	MER	John Duponte	6/15/18	9/15/18

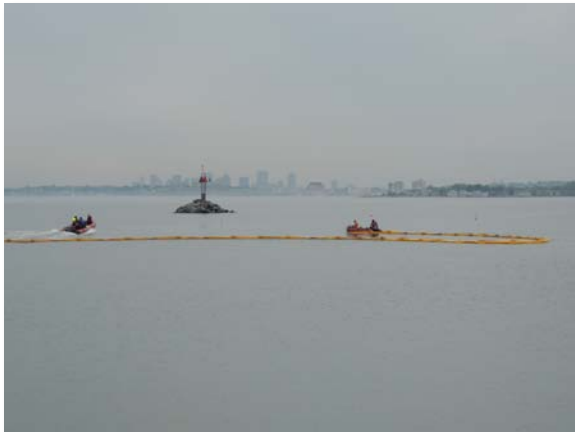
Analysis: Marine 31 (Nahant FD) got swamped when trying to pull a 300’ section of 18” boom. This was primarily attributed to inadequate vessel size in what were fairly routine environmental conditions.

Analysis: The Engine 3 boat (Lynn FD) had no cleats to safely and effectively pull boom. Its low freeboard allowed the crew to effectively connect boom in the water and handle anchor connections as well.

Lynn Engine 3 and Nahant Marine 31 work together to deploy boom.

Area for Improvement 4: Nahant Fire Department should consider procuring a larger boat to enable them to safely conduct booming operations in routine weather conditions.

Area for Improvement 5: Lynn Fire Department should consider procuring a larger boat to enable them to safely conduct booming operations in routine weather conditions

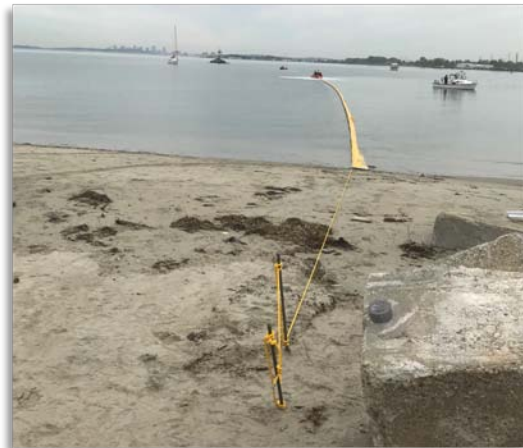
A textbook shoreside anchor is set on the beach
